TREES

Training for Renovated Energy Efficient Social housing

Section 3 Case Studies

3.5 Nürnberg – Jean-Paul-Platz (Germany)

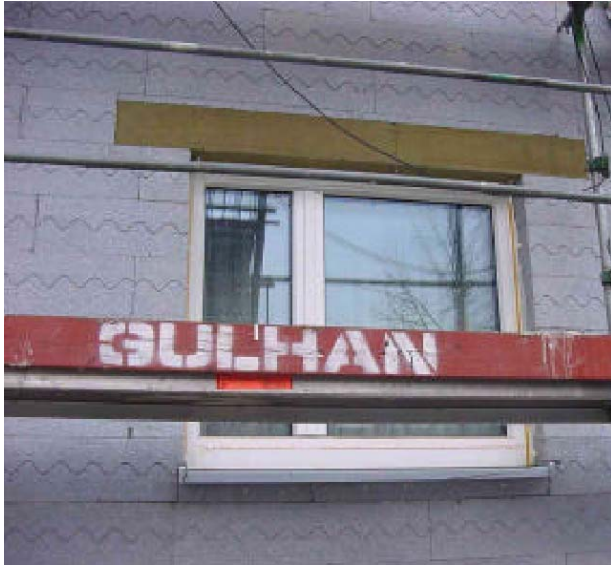
Fig. 1: Insulation of window lintels with mineral wool

According to the fire protection regulations the window lintels had to be insulated with stripes of incombustible material (e. g. mineral wool).

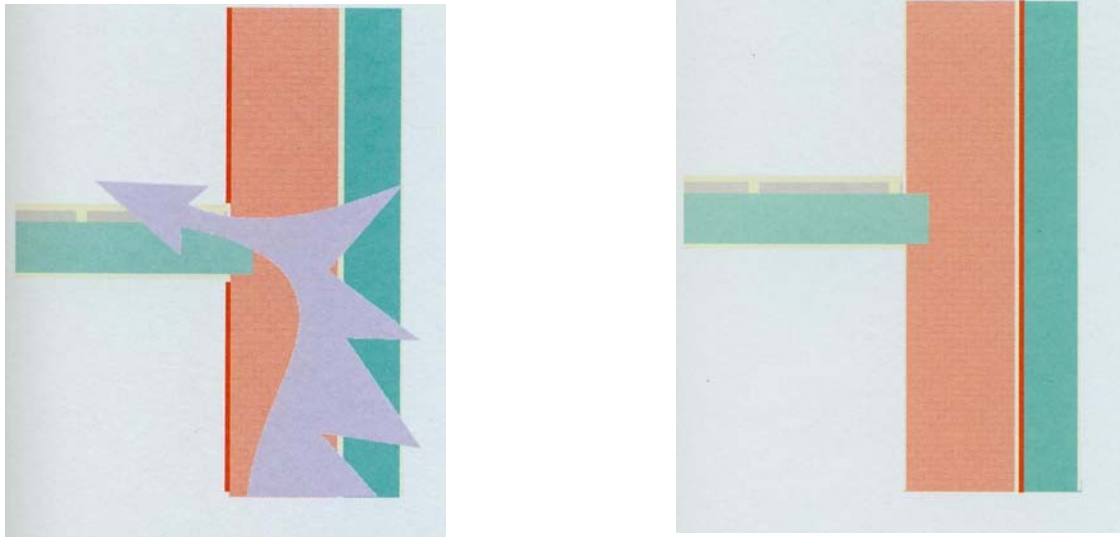
Though here the internal plaster layer is interrupted in the whole area of the support of the wooden beam ceilings; furthermore the cavities at the timber heads are open to the external walls.

Fig. 3: transferring of the airtightning layer from inside to outside plaster of external wall

Because of the ongoing inhabitation no incisive measures could be accomplished, so the airtightened layer was transferred to the outside of the exterior walls. For that the old external plaster was filled at the whole surface before the glueing of the thermoskin (especially at patches with slack, knocked off plaster and at cracks).

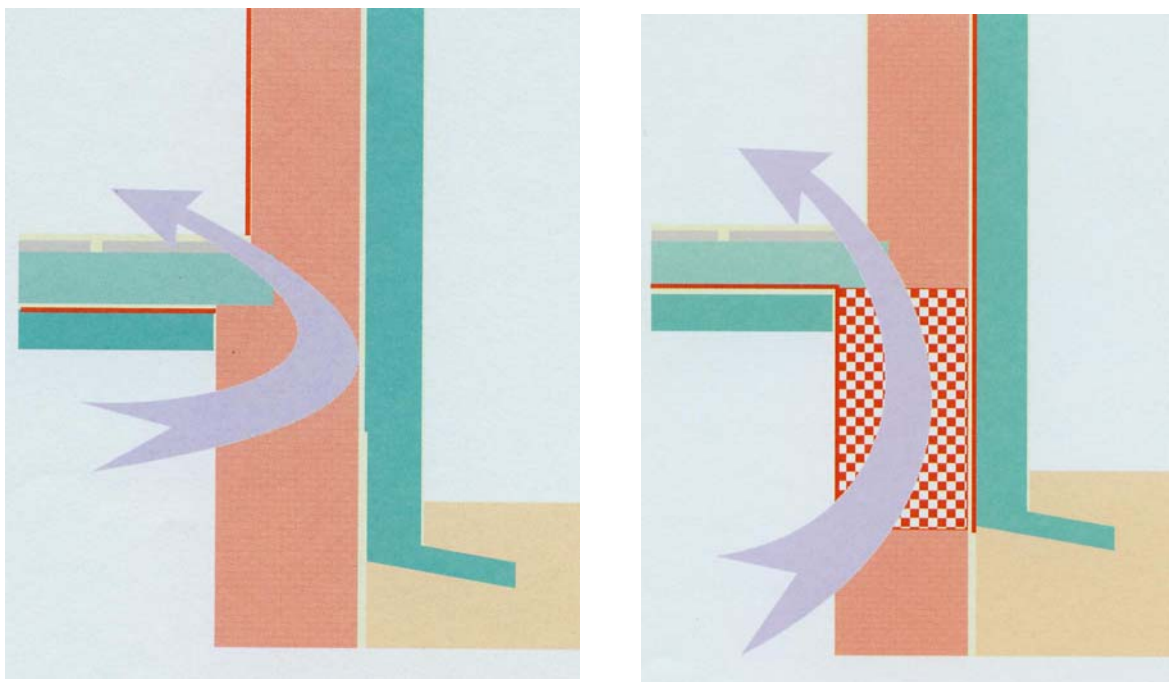
As a weak point the arising cellar brickwork remains, by which cold air from the cellar can infiltrate into the rooms of the base floor. But at this object the fully mortared brickwork, made of solid bricks, has proved sufficiently airtight. At brickwork with open grooves or made of perforated bricks this area has to be more considered.

Fig. 4: Remaining weak point at the cellar brickwork

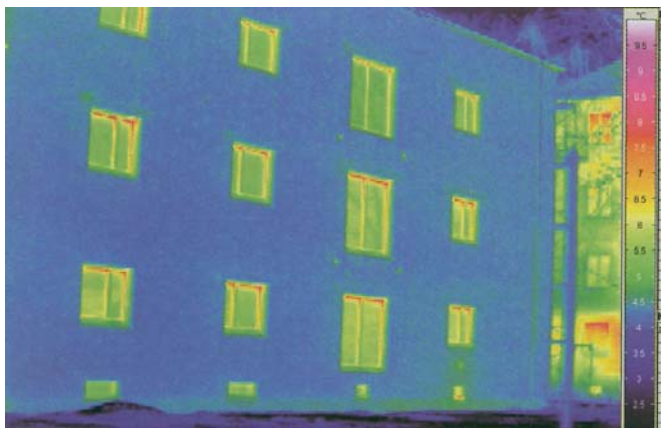
First pictures were taken already while the insulation slabs were glued at the external walls. The following picture shows the thermography of the southern facade shortly before the finishing and the mounting of the balconies. Clearly recognizable is the high quality of the insulation, which is coloured only a little warmer than the ambience (in comparison on the right side an uninsulated building, constructed in the same way). The insulation has no gaps, only the dowels are visible and, as thermal bridges, 4 stiffening anchors for the balconies.

Fig. 7: Thermography of the southern facade shortly before the finishing

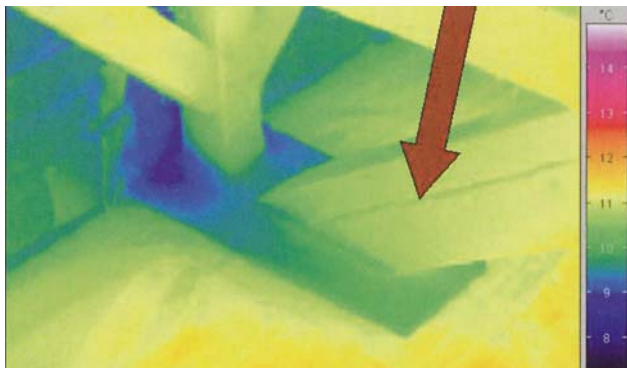
- With the thermography at over pressure it could be proved that gypsum grouting is an ideal method to seal pervasions of wooden beams through the airtight layer of the upper ceiling, because there was no visible indication for outflowing warm air.

Fig. 8: Thermography of a gypsum grouting at a pervasion of a wooden beam in the attic

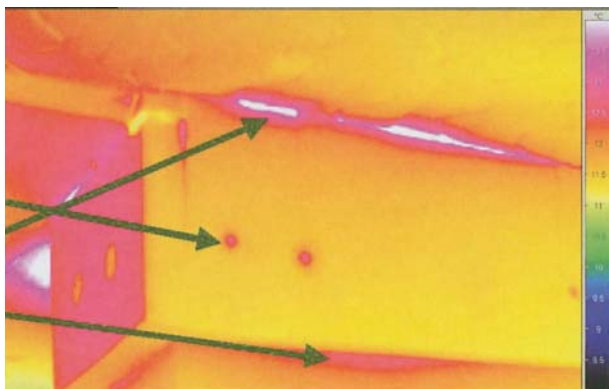
- However, in the transition of the insulation of the cellar ceiling to the insulation stripes of the cellar brickworks, there was convection through gaps in the insulation; but this could be stopped with the finishing filling plaster (but first, gaps in the insulation had to be filled with insulation material!).

Fig. 9: Thermography of the supporting insulation stripe at the insulation of the cellar ceiling
