TREES

Training for Renovated Energy Efficient Social housing

3.6 Husby terrasse - an example from Norway

- **Husby Terrasse, Norway, consist of 110 apartments, erected in the middle of 1970.**
- **Outdated technical installations and poor performance in the building envelope**
- **High potentials for improving indoor air quality**
- **Objectives of the project:**
 - Reduce energy demand from by 50 % from 250 kWh/m² yr to 125 kWh/m² yr
 - Improve indoor air and temperature quality
 - Contribute to a better LCC in a standard renovation project
 - Demonstrate innovation and promote replication
 - Contribute in a municipal sustainability project

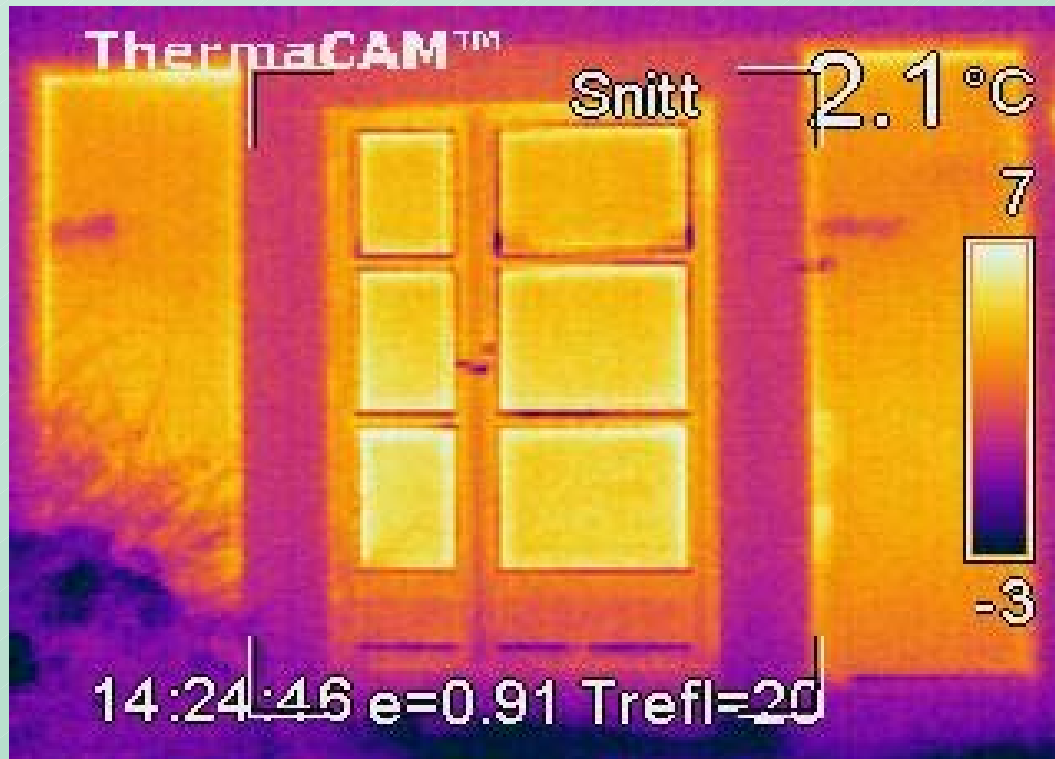
High U-value in windows and balcony door, result in heat leakage from the inside.

(photo is taken from outside)

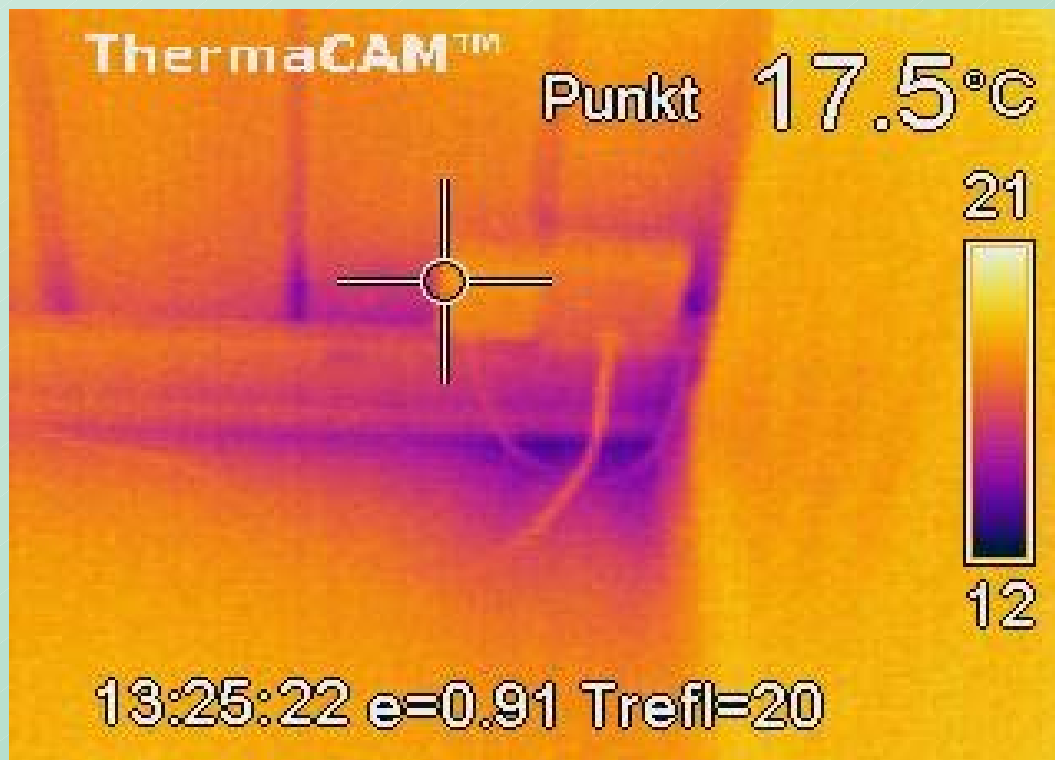
Thermal bridge in the joint between external walls and the floor (concrete slab)

(photo is taken inside)

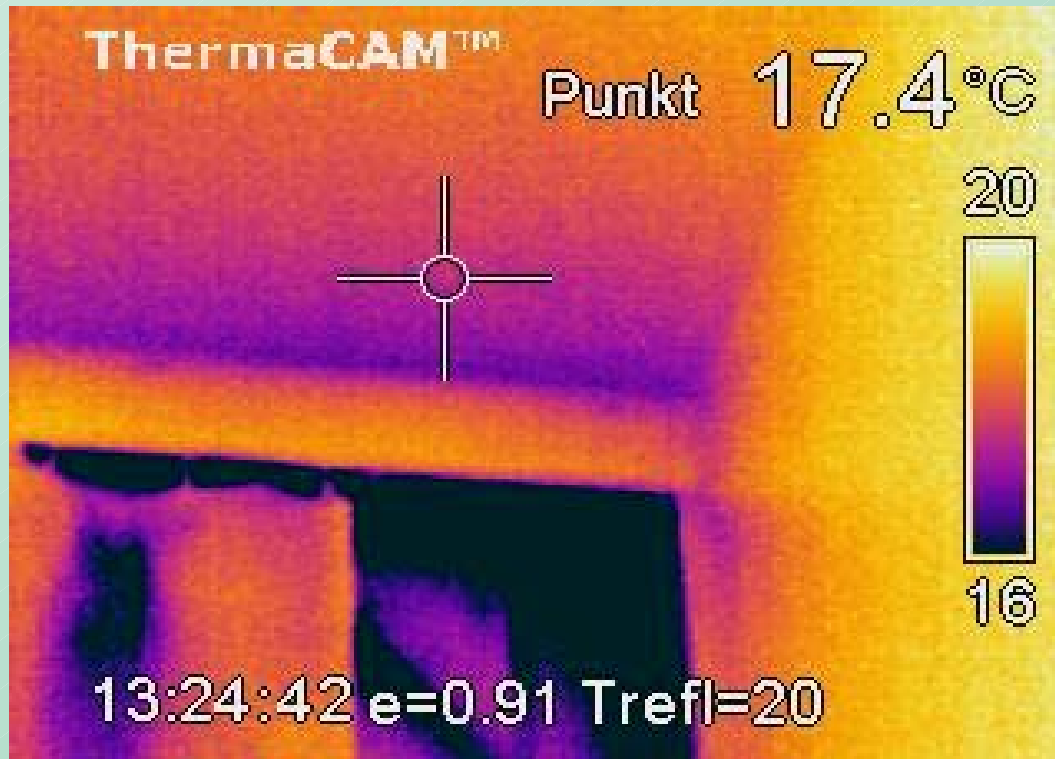
Thermal bridge in the joint between external walls and the roof (concrete slab)

(photo is taken inside)

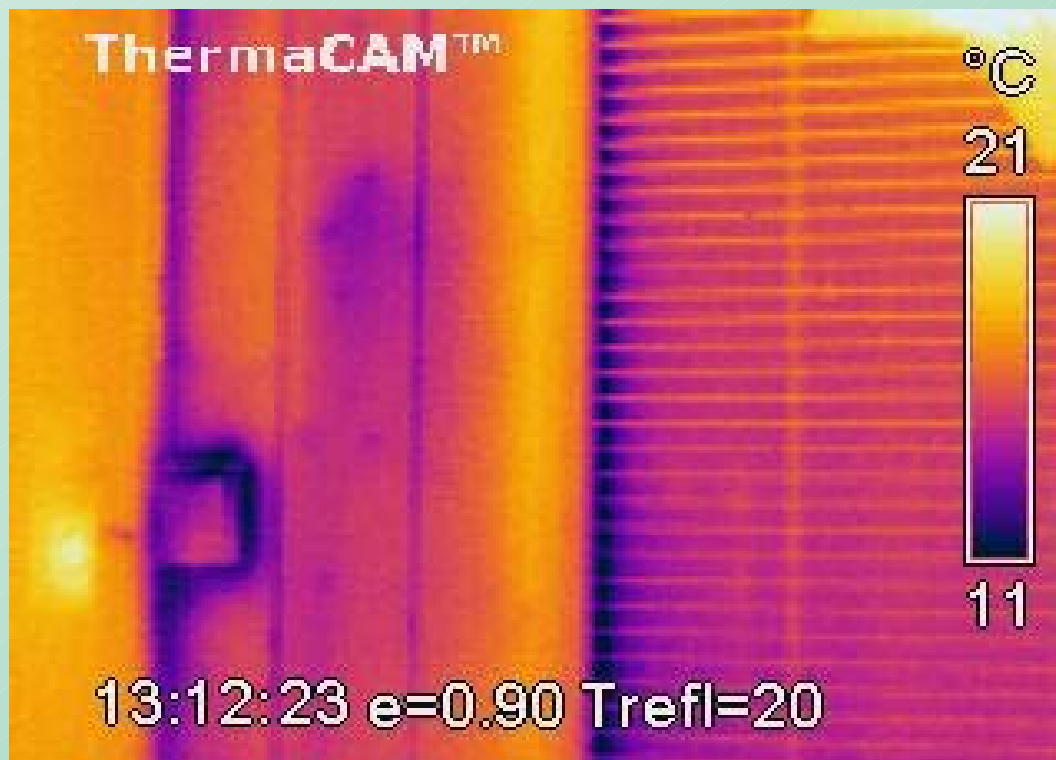
Thermal bridge /air leakage in electrical switches

(photo is taken inside)

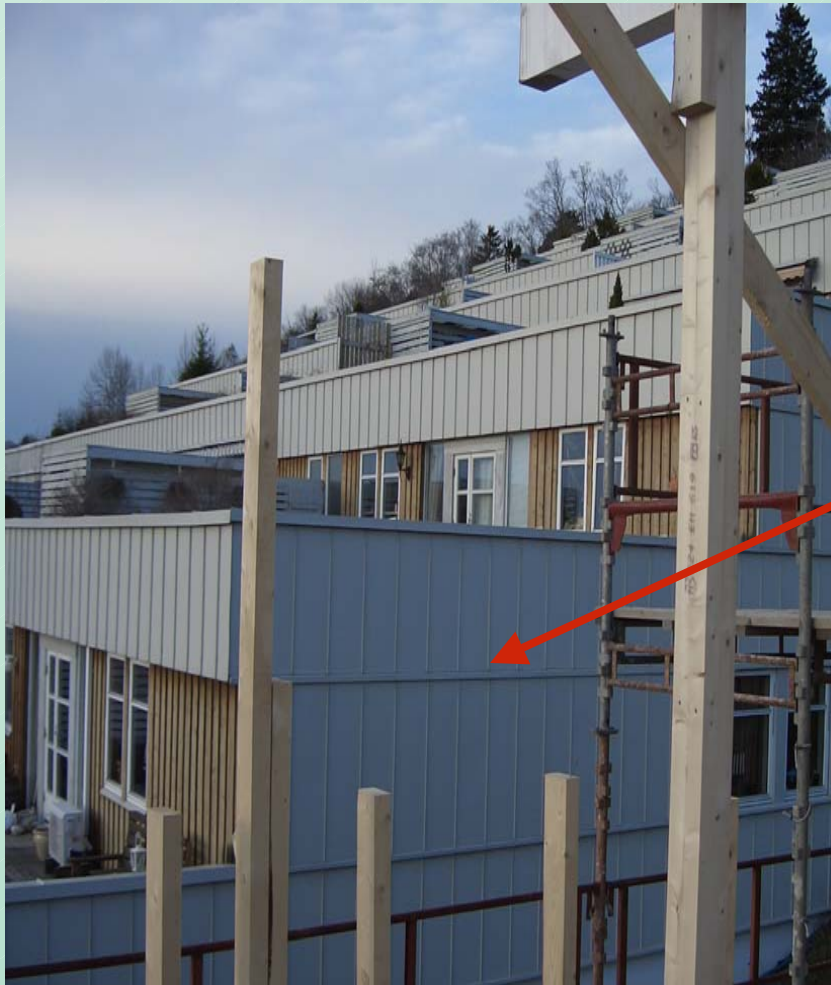
Outside wall before adding insulation.

Old steel panels. The panels are removed

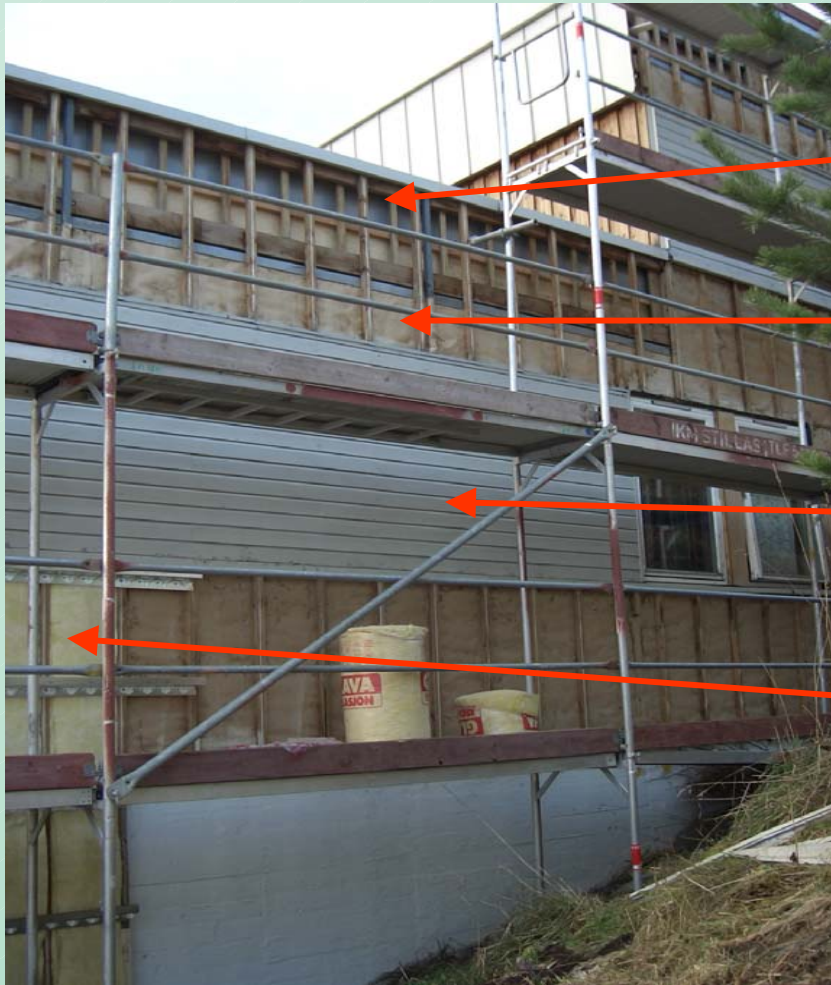
Section with removed steel panels and the old windbreaker

Section covered with old windbreaker

New steel panels

Section with 1. layer of new insulation

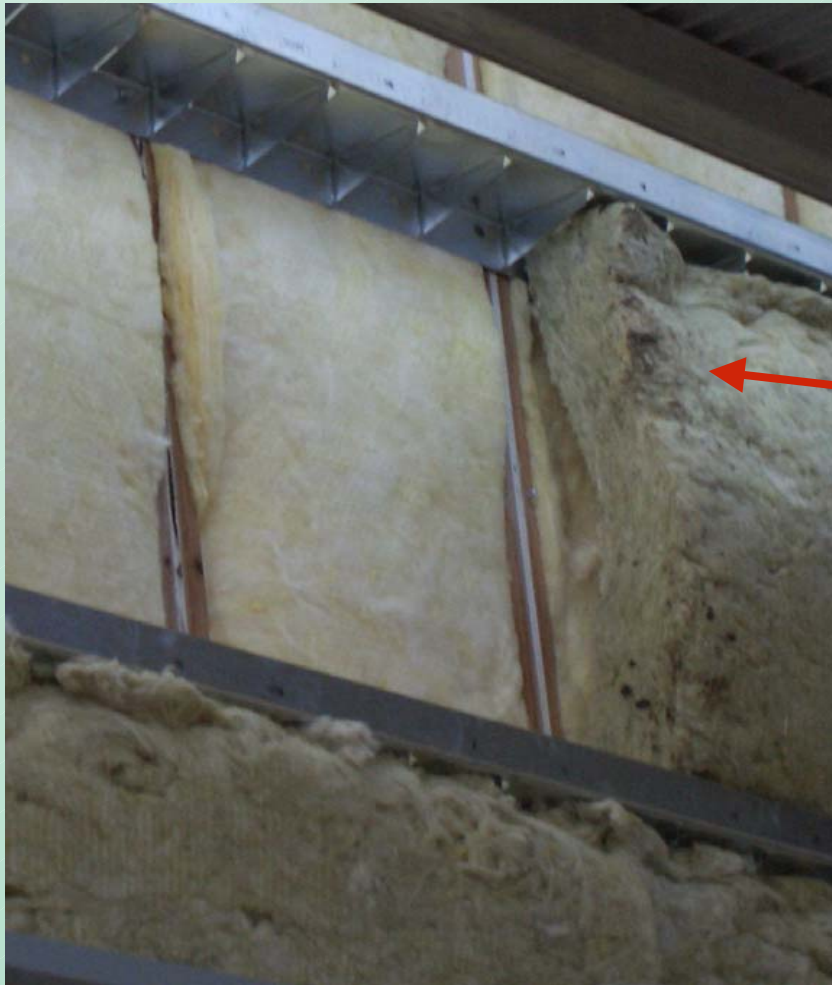
After removing the panels (and old insulation), 2 layers of insulation is added.

(Second layer)

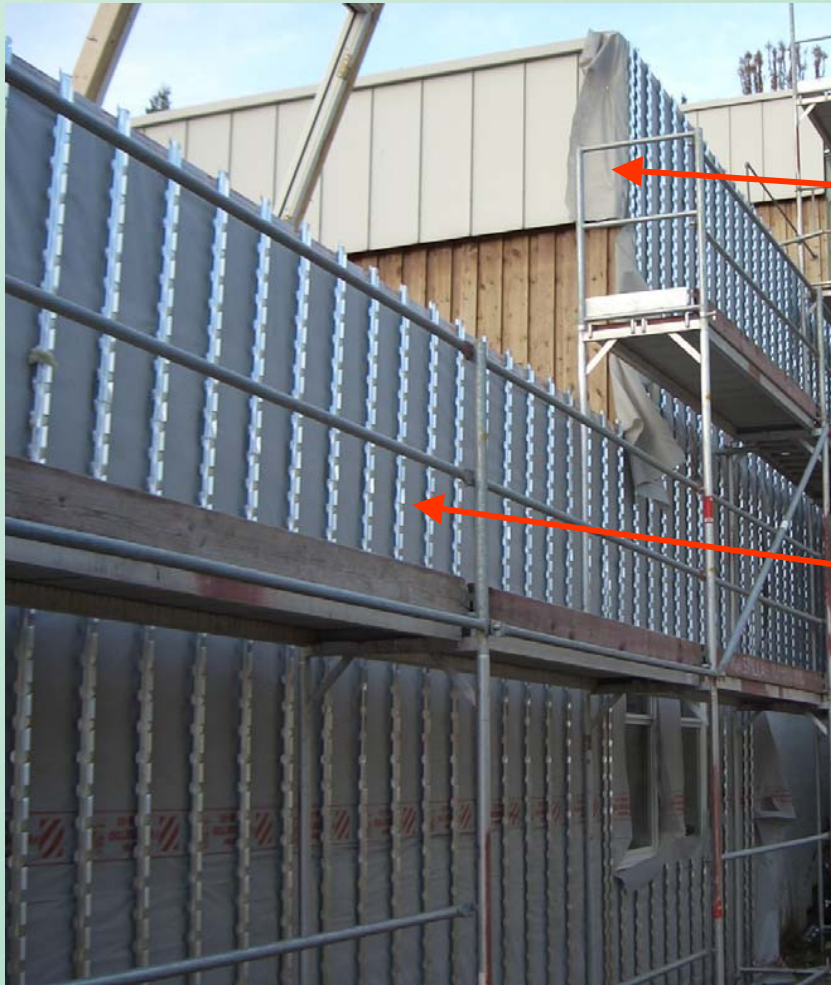
The insulation is covered with a windbreaker.

Framework to support the new panels

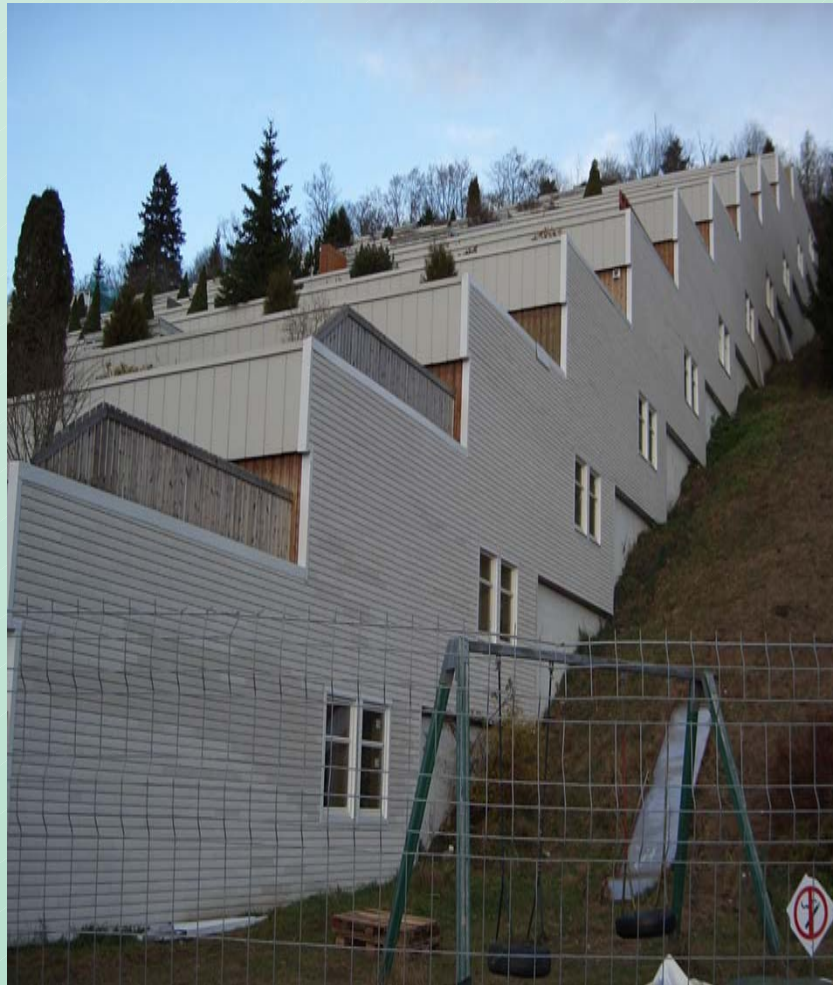
Outside wall finished

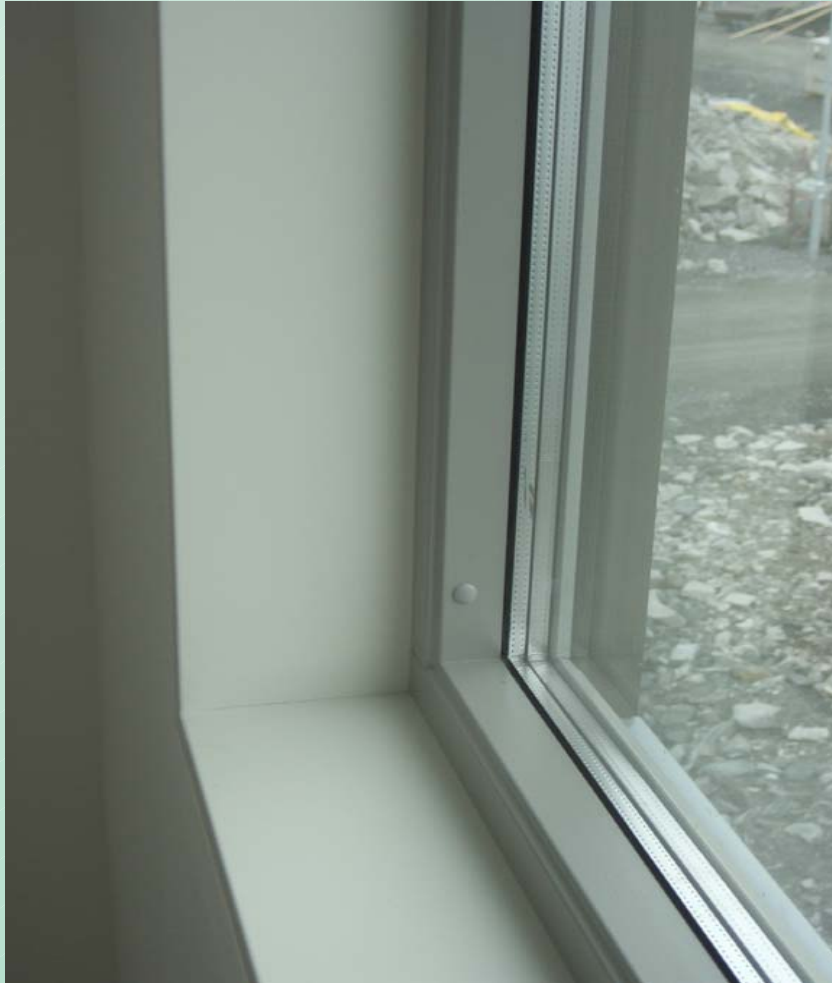
Energy efficient windows with triple glazing, 2 low emission coatings, argon gas, superspacers and wooden frame. Gives U-value of 0.95 W/m²K.
