Training for Renovated Energy Efficient Social housing

Section 3 Case studies 3.2 Dunaújváros, Hungary

Project idea: SOLANOVA

▶ Retrofit from bad state to low energy house standard

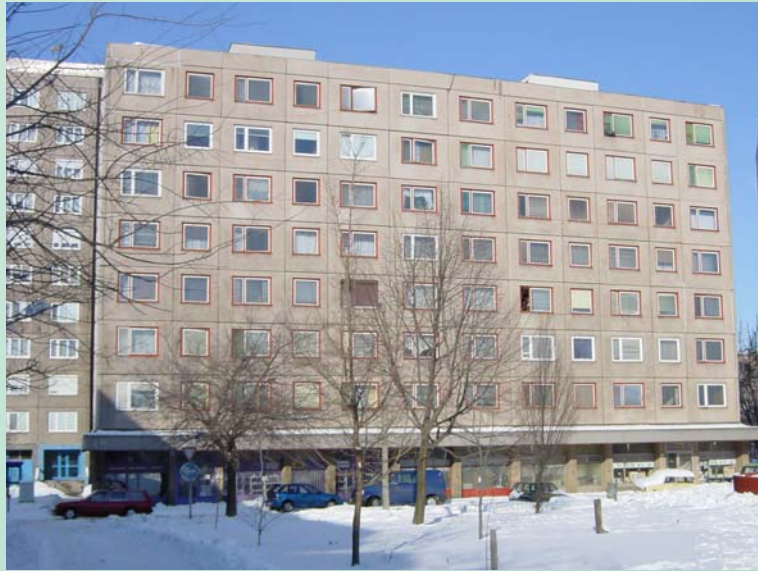
- ORIGINAL

▶ 220kWh/m²year

2005-2006: 85% saving

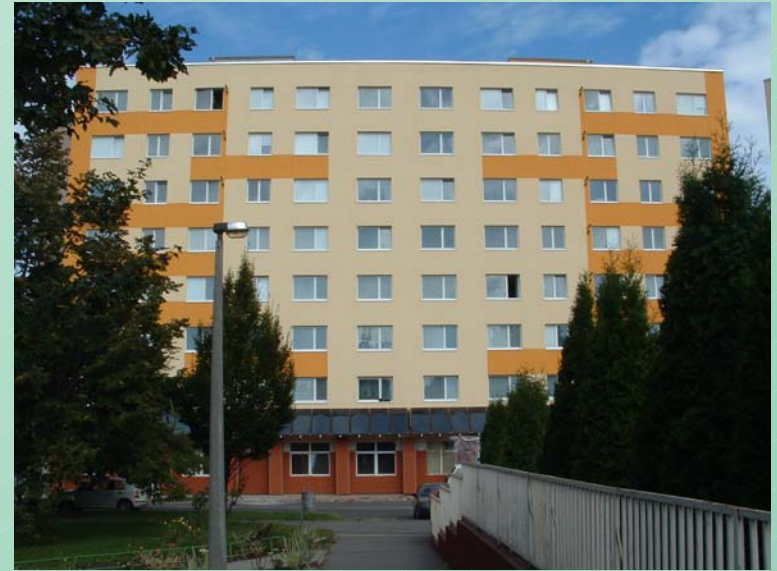
- RENOVATED

- 39 kWh/m²year

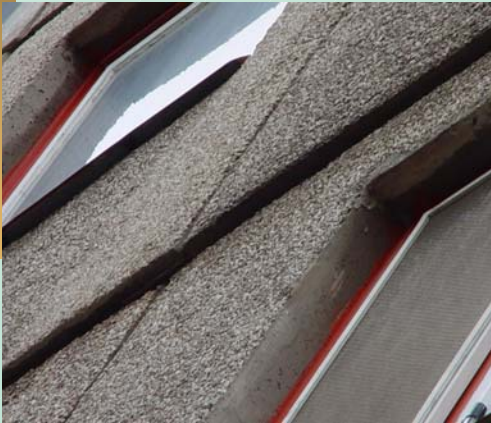
ORIGINAL

$U = 1,8-2,0$

W/m^2K

Original sandwich panels:

- ▶ **15 cm reinforced concrete – 7 cm PS – 7 cm reinforced concrete**
 - ▶ **Theoretic U-value: 0,44 W/m^2K**
 - ▶ **Real U-value in thermal bridge free zones : 0,8-1,1 W/m^2K**
 - ▶ **U-value incl. Thermal bridges: 1,8-2,0 W/m^2K**
- Insulation:
- ▶ **16 cm polistyrene**

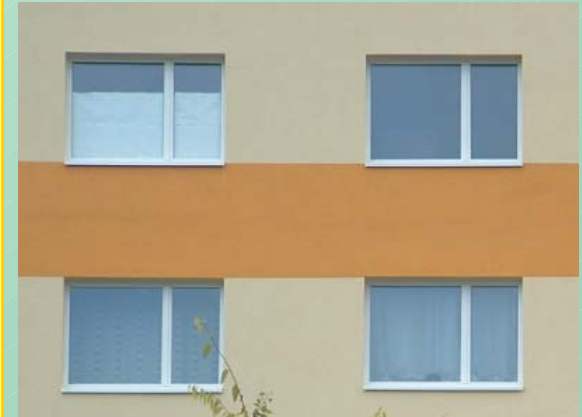
RENOVATED

$U = 0,22$
 W/m^2K

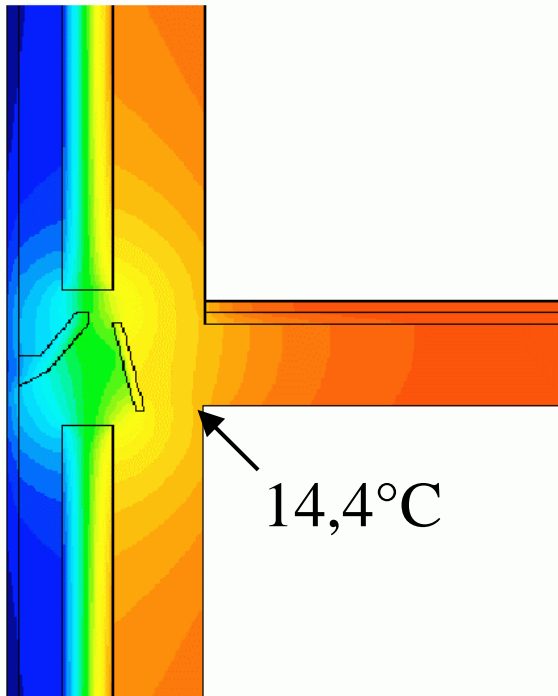
ORIGINAL

Temperature Distribution

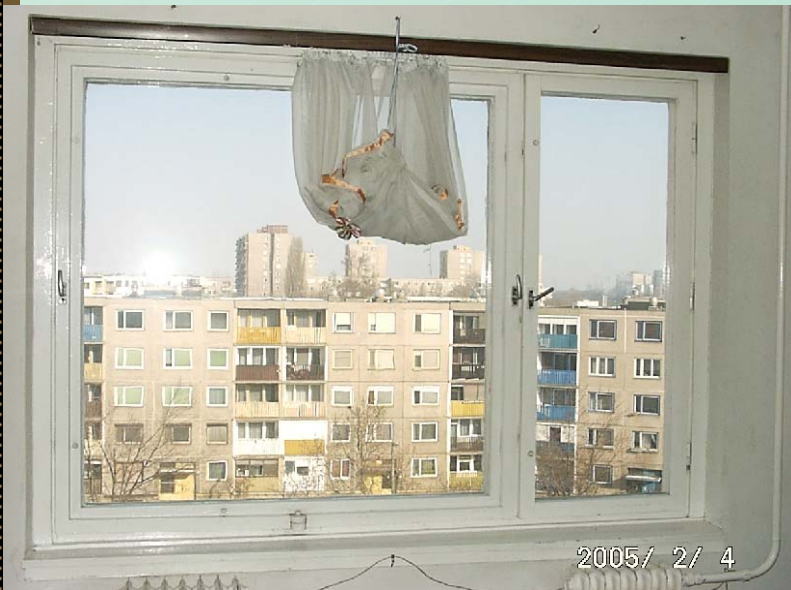
ORIGINAL

U-value element: 2,3 W/m²K

U -value installed : 3,2 W/m²K

U -value staircase : 5..6 W/m²K

U -value ground floor : 5..6 W/m²K

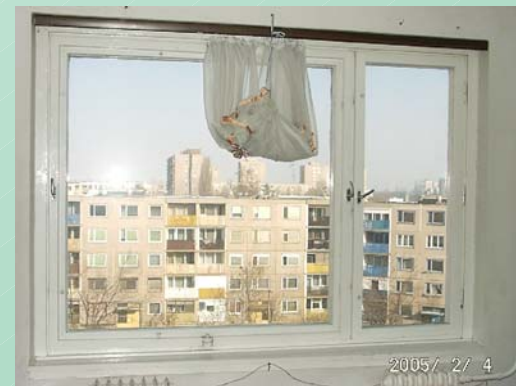
ORIGINAL

Air tightness – blower-door

Measurement in 4 flats:

| 5/1 | $n_{50} = 7,1 \text{ h}^{-1}$ |
| 5/2 | $n_{50} = 8,8 \text{ h}^{-1}$ |
| 5/3 | $n_{50} = 9,1 \text{ h}^{-1}$ |
| 7/3 | $n_{50} = 12,0 \text{ h}^{-1}$ |

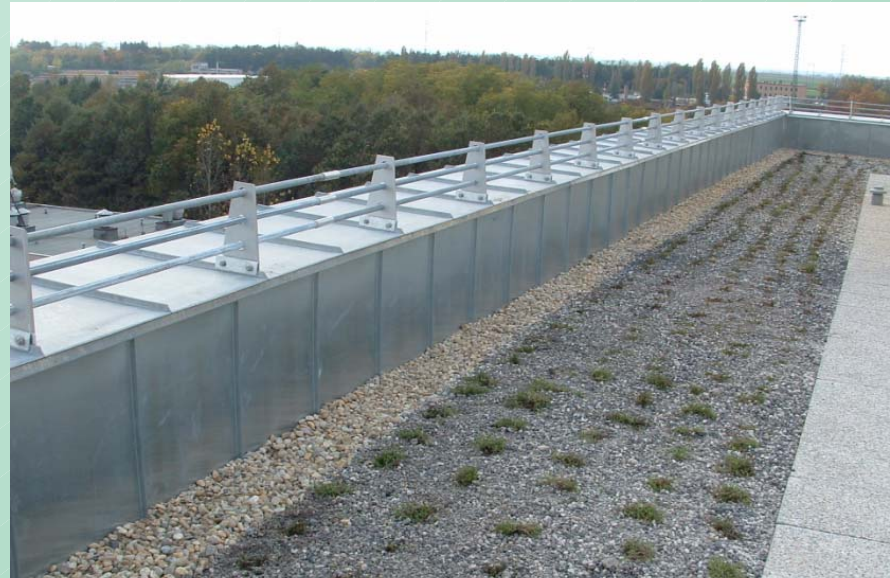
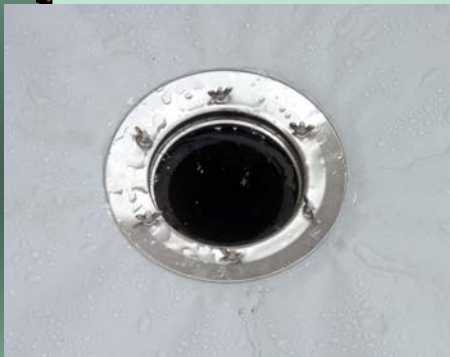
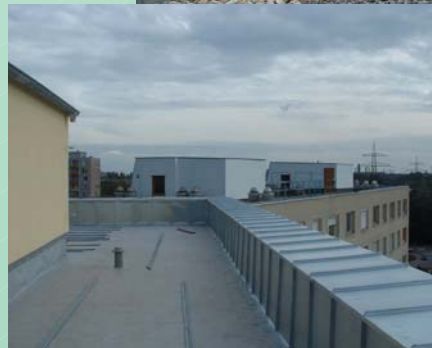
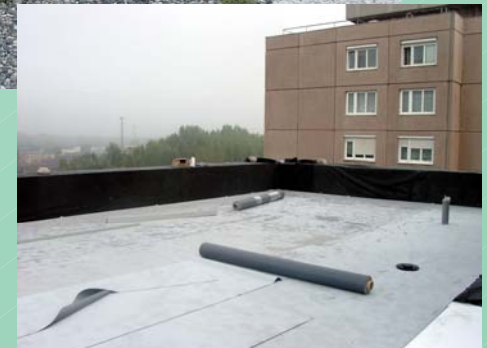
Flat roof

$$U = 1,3 \text{ W/m}^2\text{K}$$

$$U = 0,12 \text{ W/m}^2\text{K}$$

21-29 cm PS

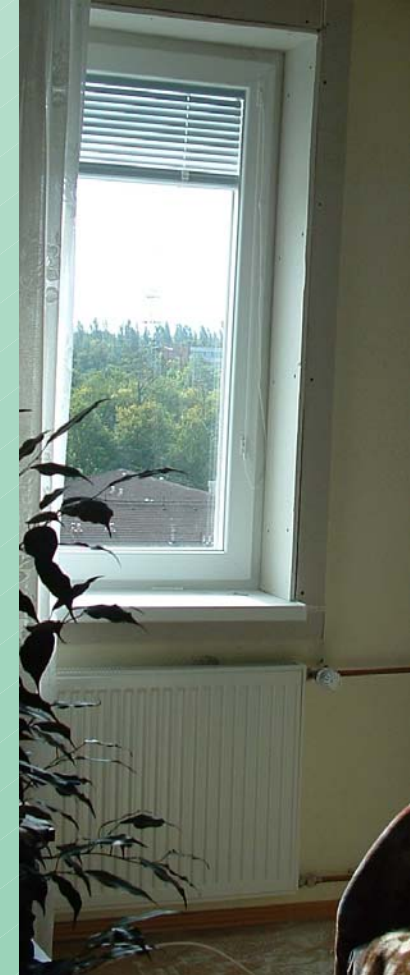
RENOVATED

- Much smaller radiators
- One instead of two in each rooms
- Thermostatic valves
- Risk of overheating due to the uncontrolled heat flow of pipes
- Minimised total pipe length
- Unheated staircase

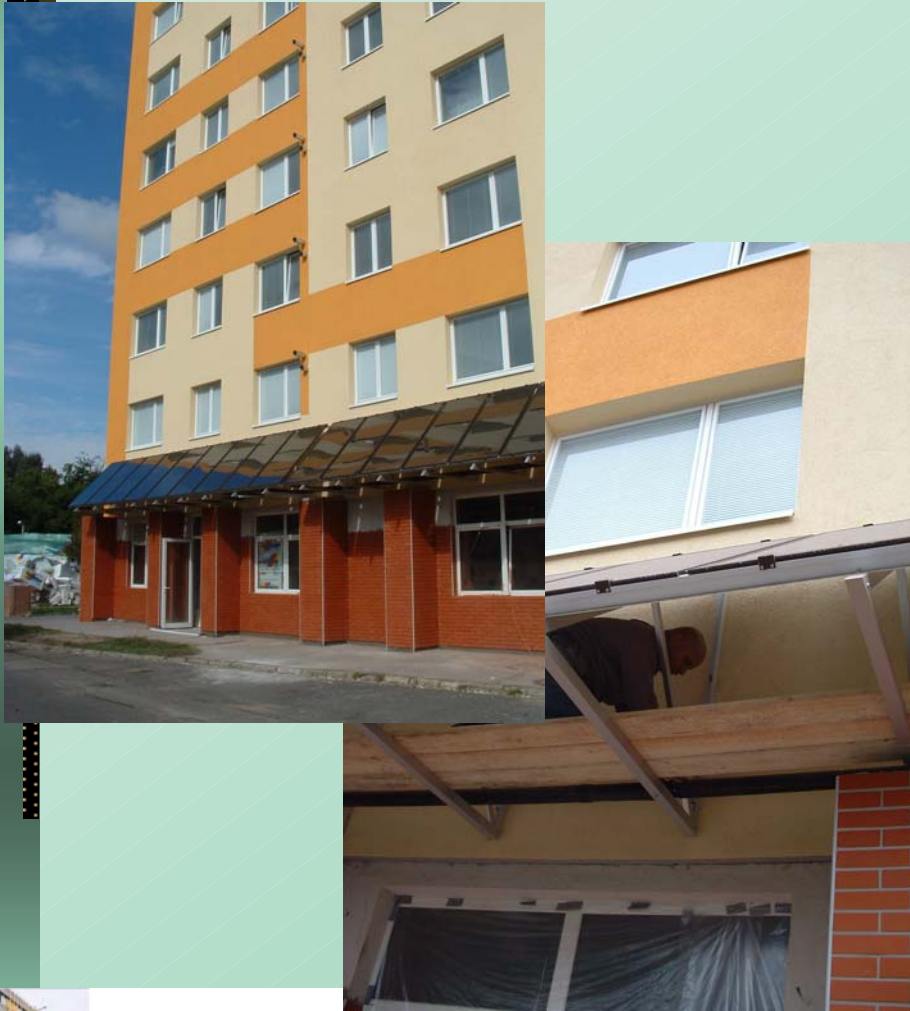
Solar system

- Canopy integrated system on the Southern side: double function, shorter pay-back time
- 72 m²
- supports DHW production
- Solar+water saving: 50% DHW energy saving

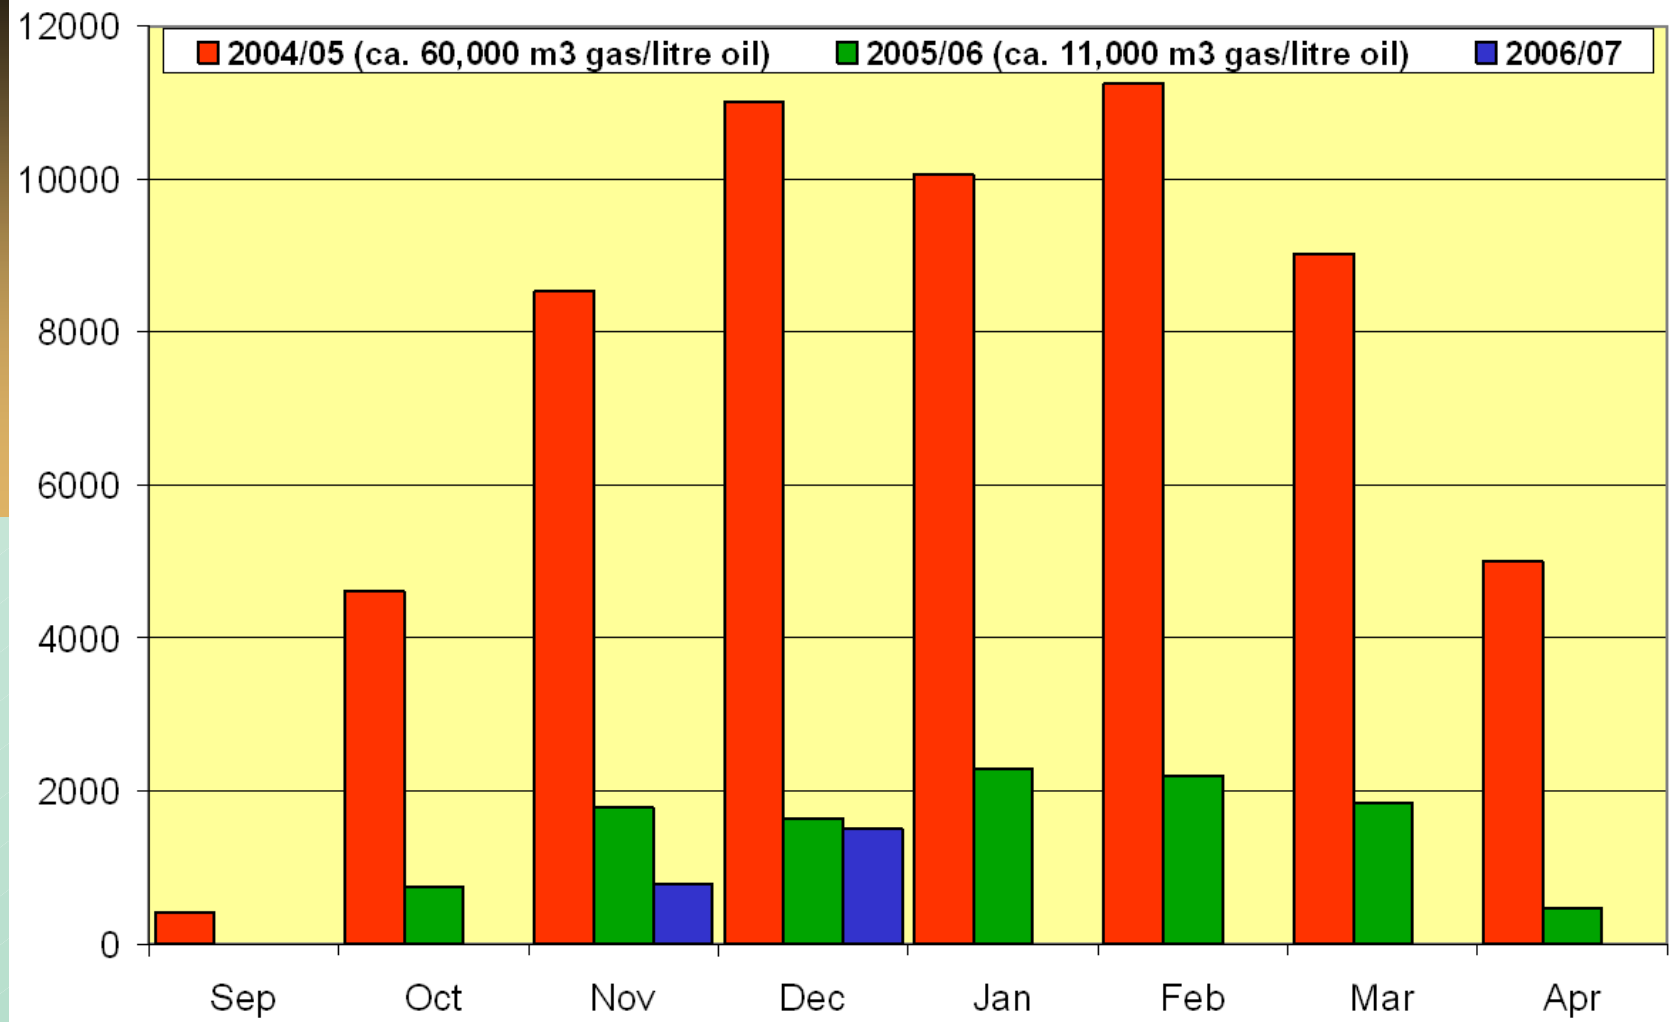
Monthly energy consumption before and after renovation

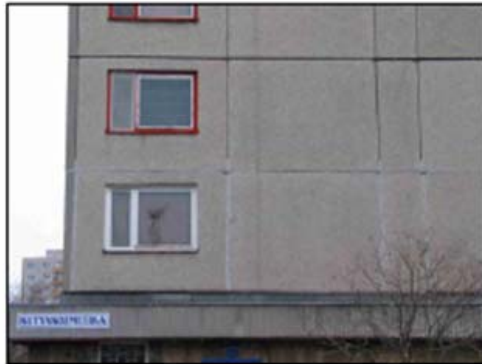
Thermography before and after renovation

| Dátum/Date | 2004.02.11. |
| Időpont/Time | 9:04:27 |
| T külső/T outside | -0,8°C |

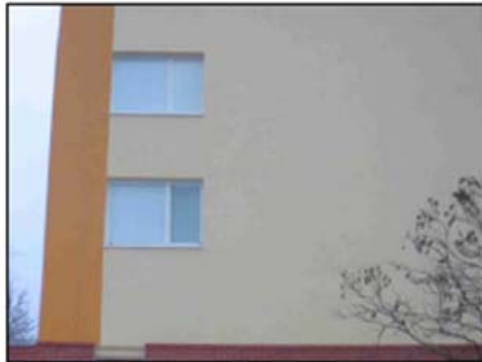
| Dátum/Date | 2006.01.13. |
| Időpont/Time | 7:49:34 |
| T külső/T outside | -3,5°C |

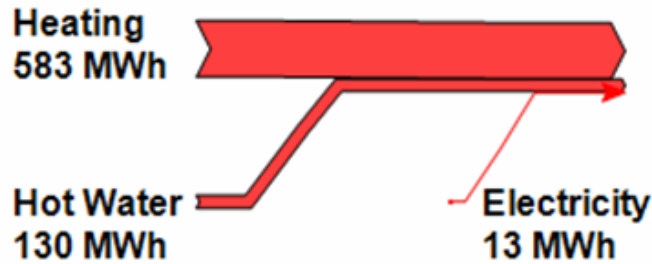
Sankey diagrams

Before refurbishment

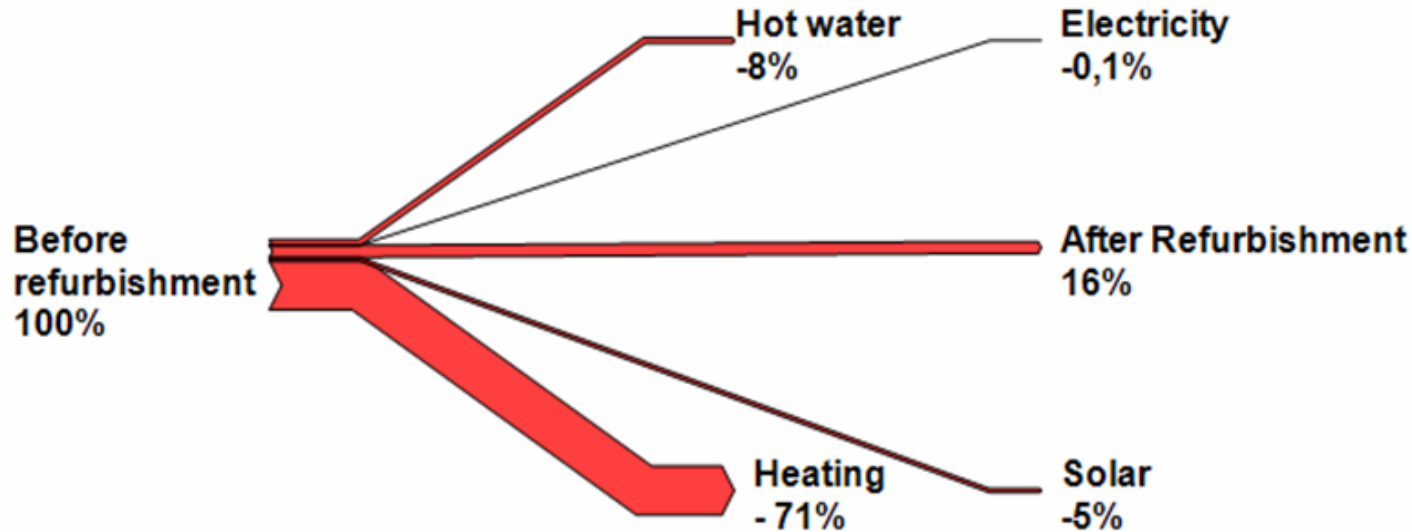
Propotions of saving

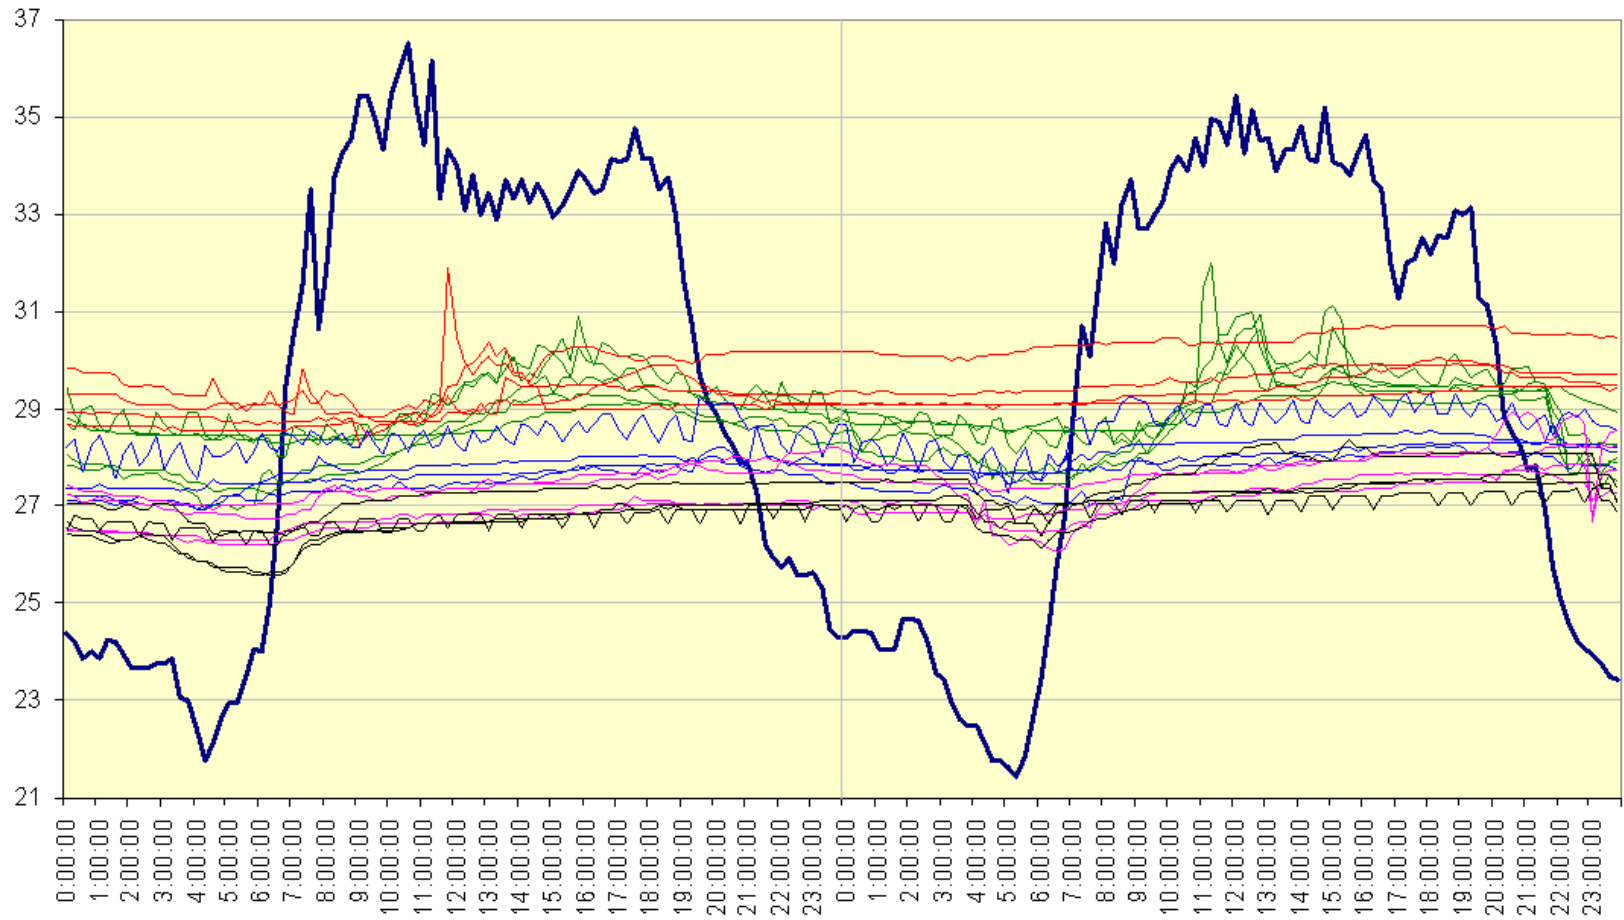
Air temperatures in 22-23 July 2006
